ANNUAL REPORT FOR 2008

**UT to Cold Water Creek Mitigation Site
Cabarrus County
TIP No. R-2533B (Site 23)**

Prepared By:
Natural Environment Unit & Roadside Environmental Unit
North Carolina Department of Transportation
September 2008

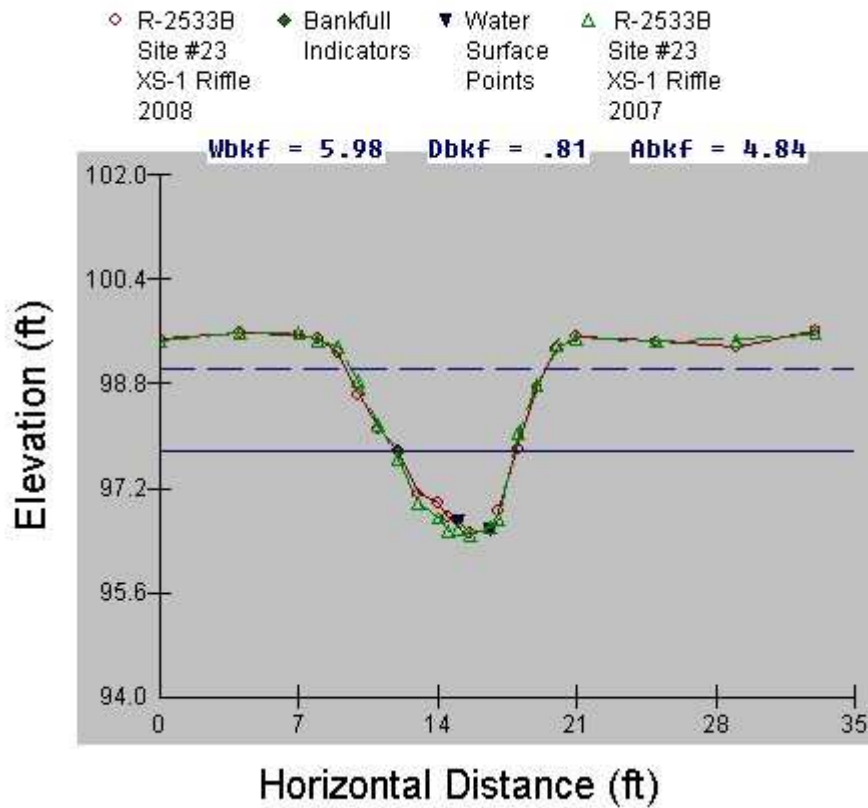
R-2533B Site #23 XS-1 Riffle

Based on comparisons of Year 2007 and Year 2008 monitoring data, all of the cross sections appear stable with little or no active bank erosion. A bankfull event has occurred since the last monitoring evaluation. Graphs of the cross sections are presented in Appendix A. Future survey data will vary depending on actual location of rod placement and alignment; however this information should remain similar in appearance. Pebble counts were not required per the permit conditions and therefore were not completed.

Site #23: Cross-Section #1 (Riffle) Abbreviated Morphological Summary

2007	2008	2009	2010	2011
Bankfull Cross Sectional Area (ft ²)	4.6	4.8			
Maximum Bankfull Depth (ft)	1.2	1.3			
Width of the Floodprone Area (ft)	9.0	10.2			
Bankfull Mean Depth (ft)	0.8	0.8			
Width/Depth Ratio	7.0	7.4			
Entrenchment Ratio	1.6	1.7			
Bankfull Width (ft)	5.7	6.0

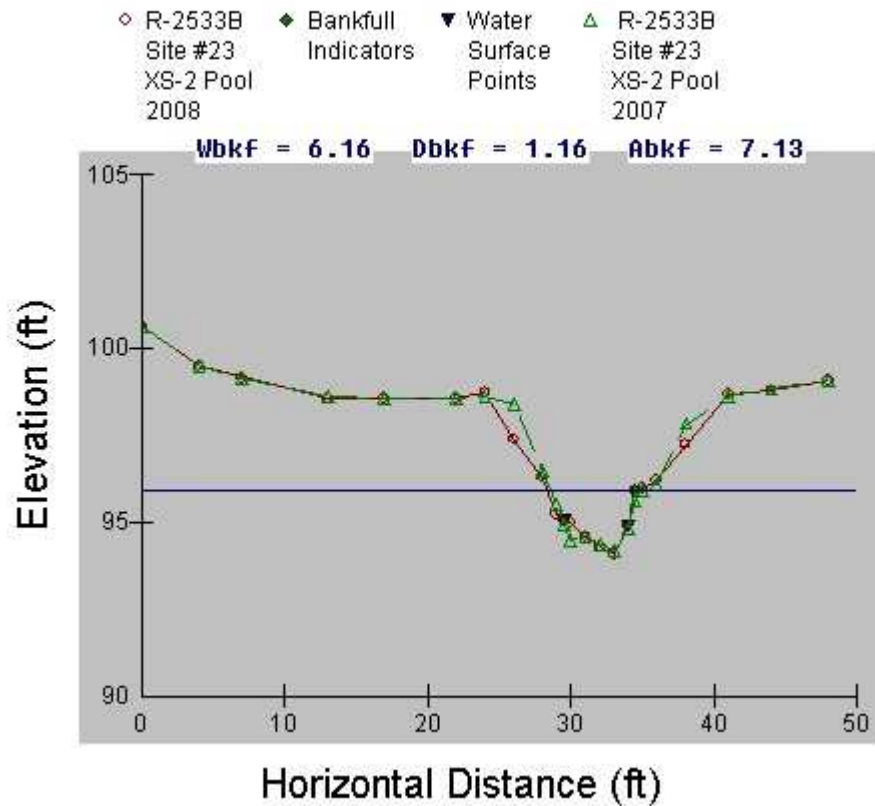
R-2533 Site #23 XS-2 Pool

Site #23: Cross-Section #2 (Pool) Abbreviated Morphological Summary*

2007	2008	2009	2010	2011
Bankfull Cross Sectional Area (ft ²)	7.83	7.1			
Maximum Bankfull Depth (ft)	1.39	1.9			
Bankfull Mean Depth (ft)	0.86	1.2			
Bankfull Width (ft)	9.13	6.2
